May 2009

Rio Piedras Conservation Management Plan

RIO PIEDRAS CONSERVATION MANAGEMENT PLAN

Prepared For: The Conservation Trust of Puerto Rico

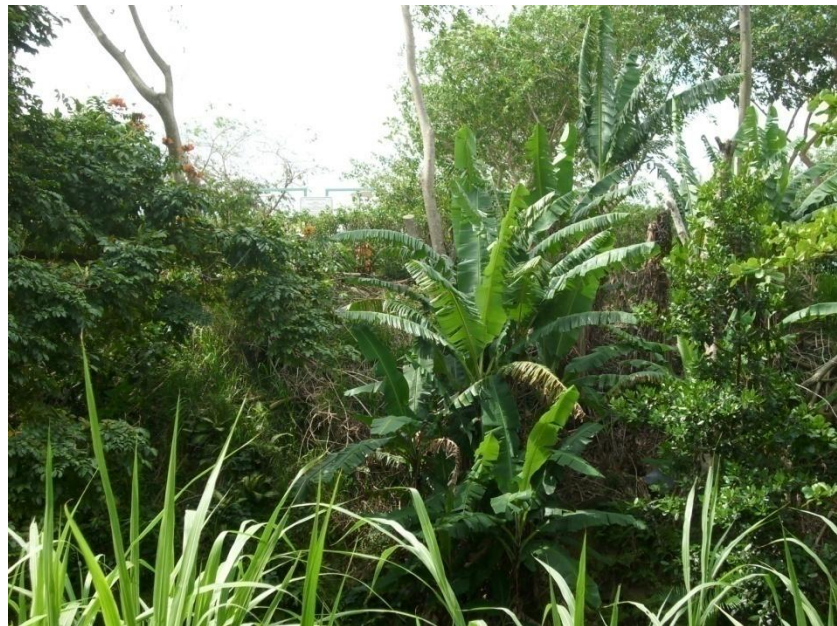
Figure 12: McArthur Palm and Zone 3 (Building in Far Background)

The soil samples from Zone 3 are varied from place to place. The first sample, taken from the top of the bank, is a loose soil that contains rocks with a small amount of roots and organic matter. This soil is prone to erosion as there are not enough roots to hold the soil in place. The second sample was taken at the end of the zone and contains hard

packed clay that was very slippery. The packed clay contains a few minute roots. The sample exhibits the zone's typical bank close to the water's edge. This type of bank allows for the growth of moss, small shrubs, and small grasses. Consequently, the bank is eroded and very steep. The first sample has a density of 0.765 g/cm^3 while the second sample has a density of

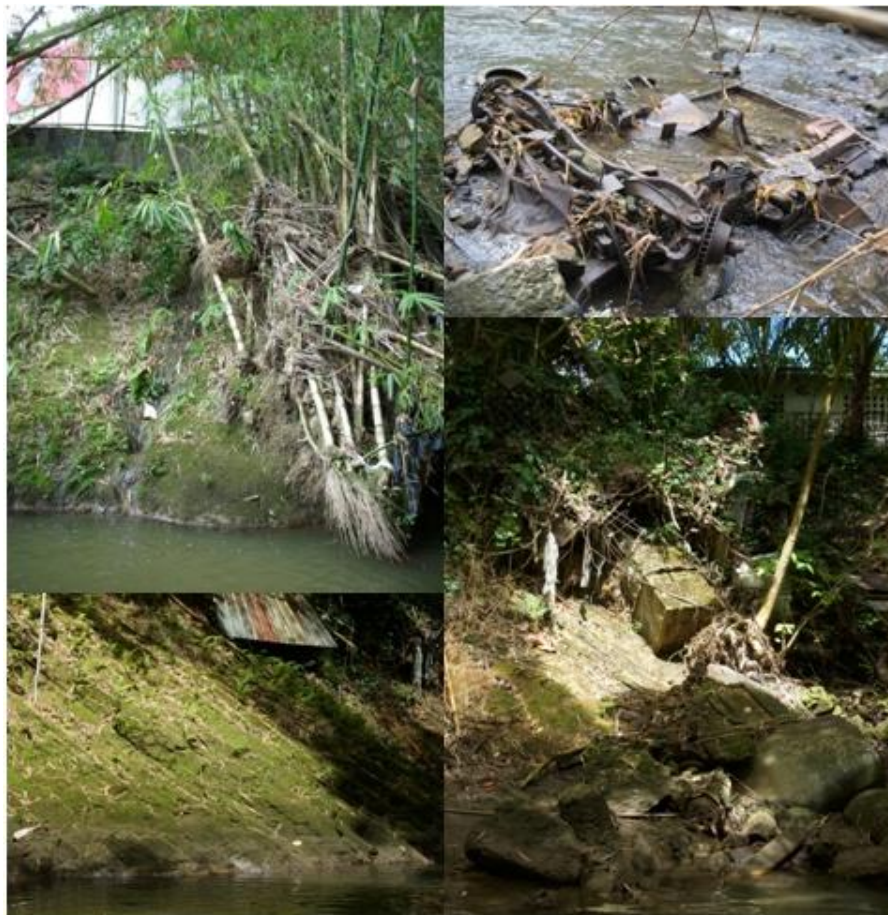
Figure 13: Features of Zone 4

Intervals 6, 7, 8, 9, and 10 are grouped together to form the one hundred fifty-meter Zone 4. This zone marks the point where urban development meets the river's riparian zone. Consequently, an excessive amount of human debris characterizes the zone. At the end of the zone, items such as scrap metal, televisions, tires, and a car chassis are present. The canopy

cover consists largely of Bamboo, positioned at the peak of the bank where the riparian zone meets a concrete foundation and fence. There are also scattered trees within the zone and little undergrowth. Some of the debris items, erosion, and bank composition can be seen in Figure 13. The resulting weak soil has caused Bamboo trees to upend and they are on

the verge of falling into the river. The moss covered banks are very steep and house various sized rocks. This zone distinguishes itself because it accommodates Bamboo and is surrounded by numerous buildings. These features may be the cause of the severe erosion and urban dumping that also distinguish the zone. Recognizable features can be seen in Figure 14 and Figure 15.
